Schomberg Plaza Fire New York City (Harlem)

Schomberg Plaza Fire New York City (Harlem) (March 22, 1987)

This is Report 004 of the Major Fires Investigation Project conducted by TriData Corporation under contract EMW-86-C-2277 to the United States Fire Administration, Federal Emergency Management Agency.

BOARD OF INQUIRY
INTO THE MARCH 22, 1987
SCHOMBURGE PLAZA FIRE
PRELIMINARY REPORT

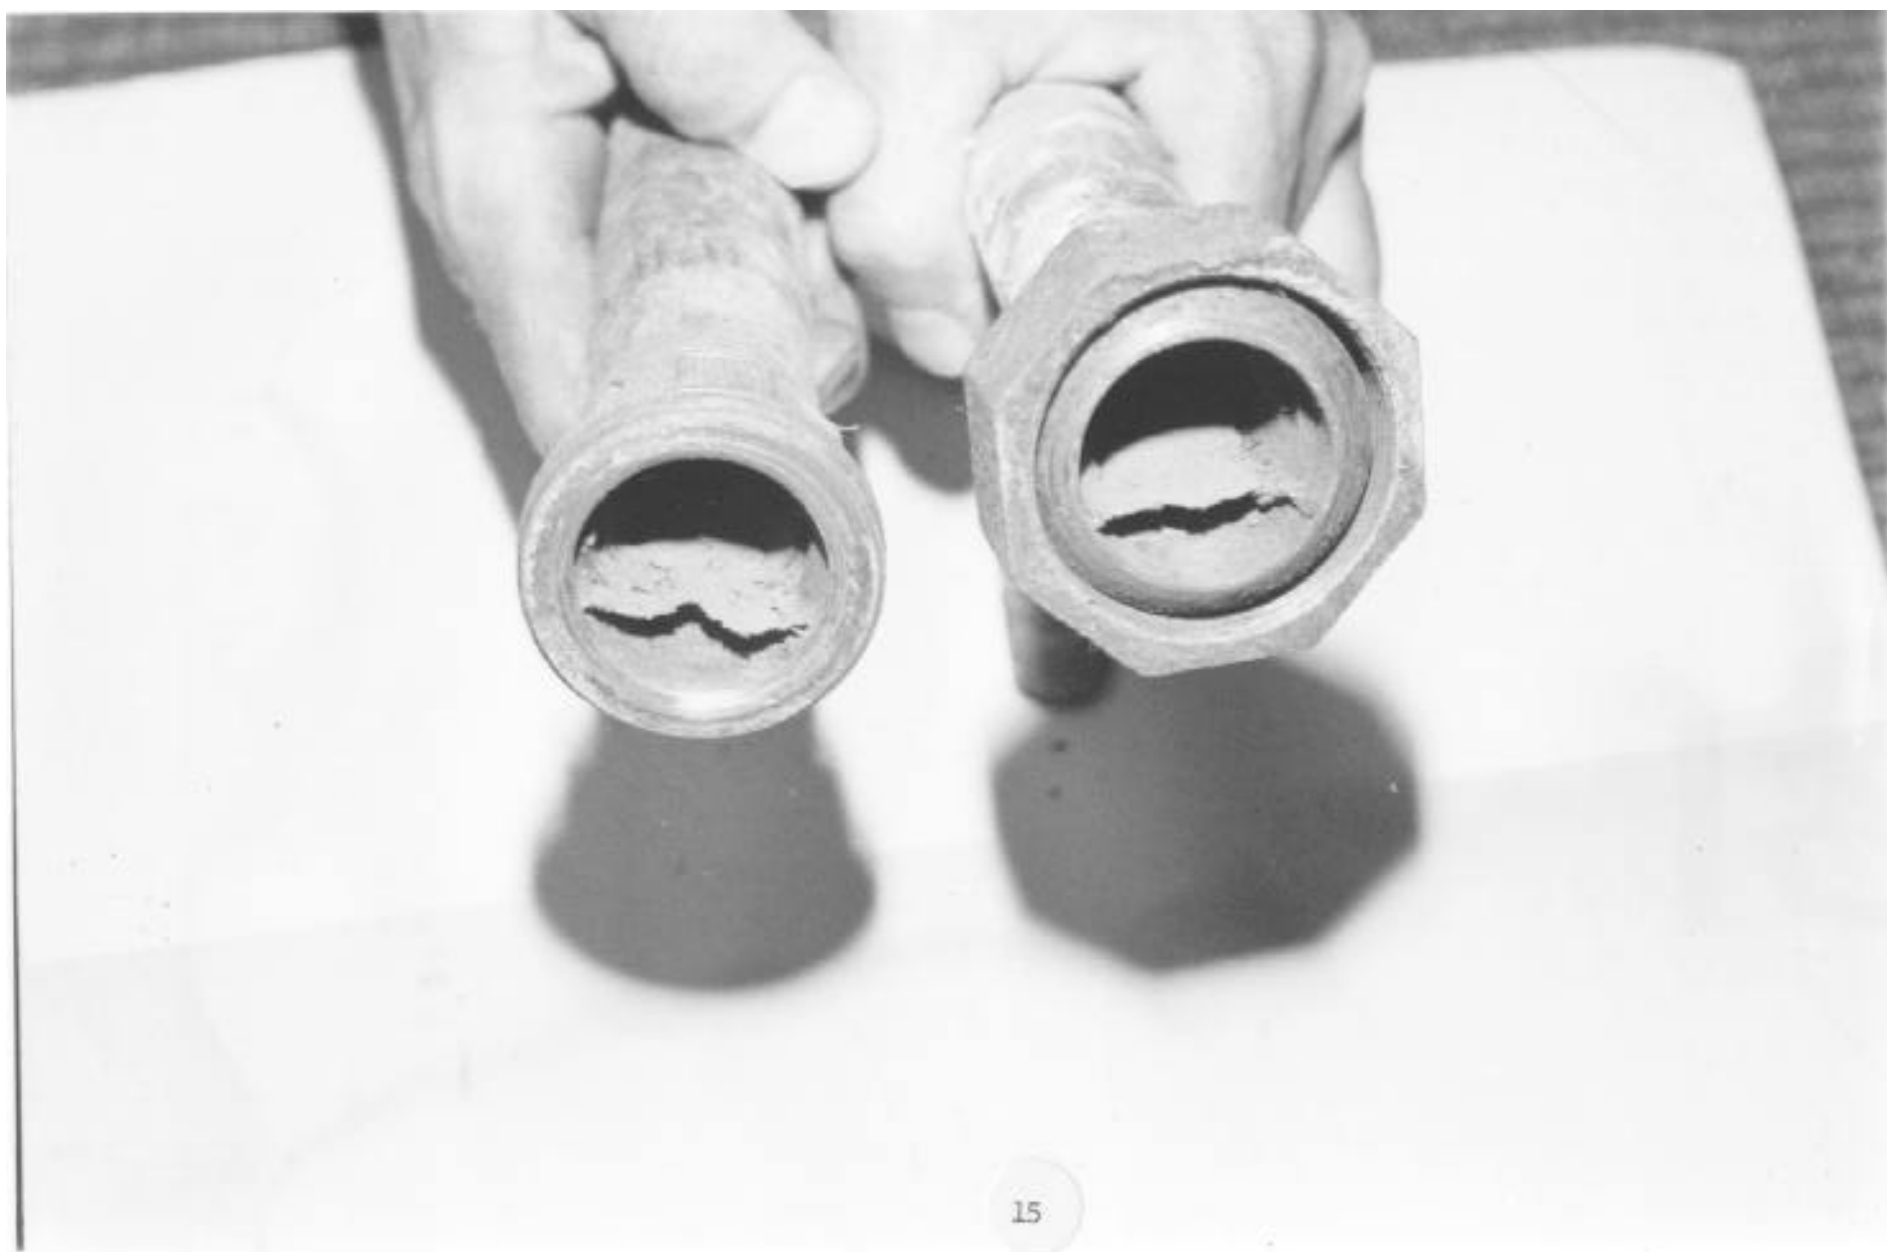
15. Horizontal piping with solidified silt and rust.
16. Evidence voucher. (Sample)
17. Sprinkler shut off valve in dayroom, 1st floor.
18. Sprinkler shut off valve in closet (compactor) on 35th floor at ceiling.
